Pacific Islands Applied Geo-science Commission

Report Title: PACIFIC HYCOS MISSION TO TONGA

Date: 21 June– 25 June 2010

SOPAC Trip Report 458 – Sinclair & Liava'a

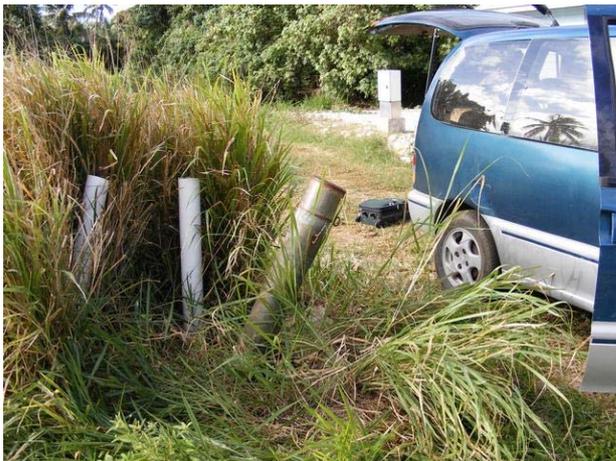
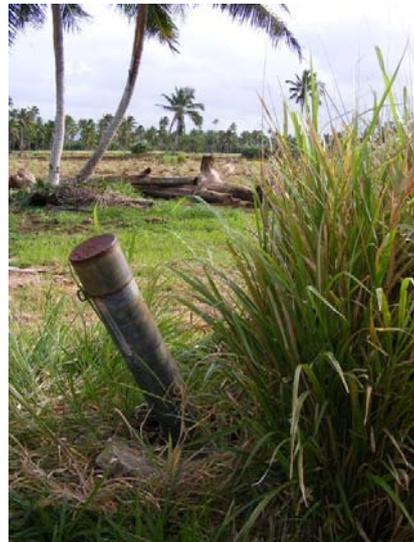
The joint mission with B Envelope facilitated TWB's involvement in the installation of the rain gauge and the rehabilitation of the damaged bores MB4 and MB5. This relationship is to be promoted through continued joint monitoring activities and the sharing of data.

Damaged MB 4 – Mataki'eua

Rehabilitation of MB4

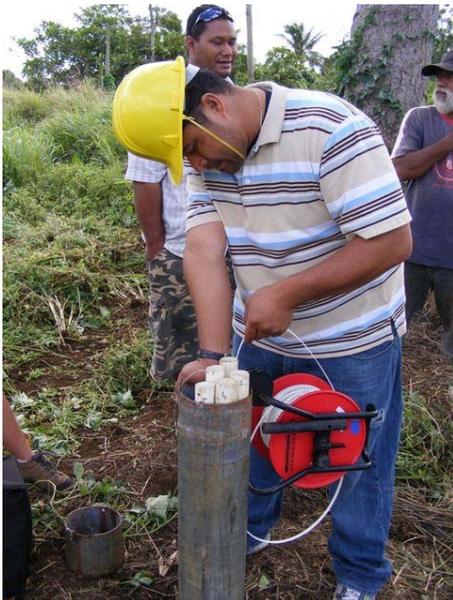
Water level measurement of monitoring bores

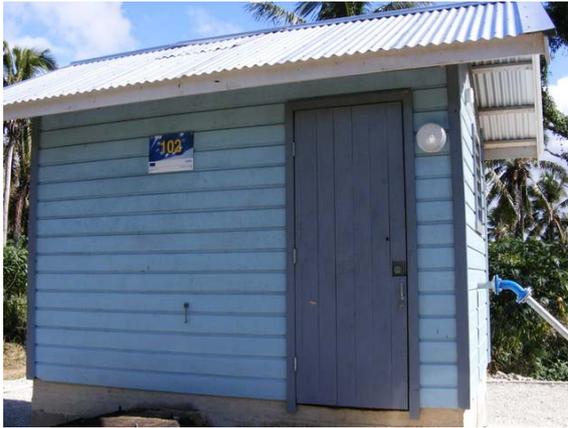
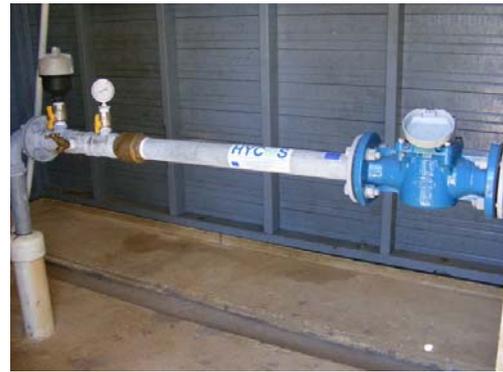
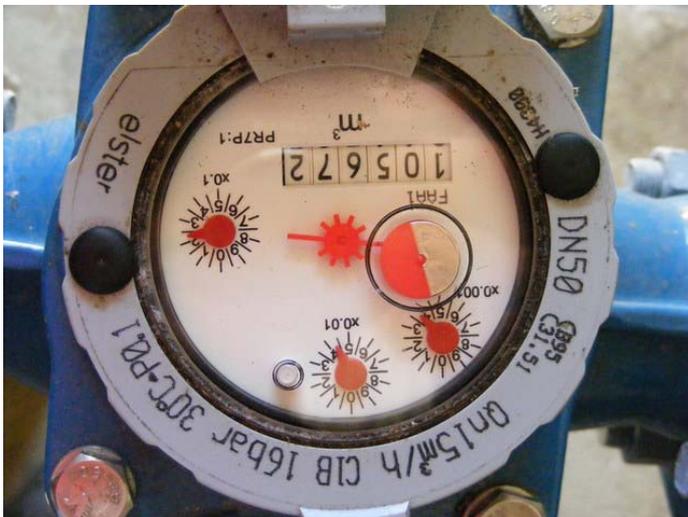
An inspection was made of 2 of 23 the newly constructed B Envelope funded pump houses in Mataki'eua. HYCOS provided meters and associated pipe works including gate valves for some 37 installations, which will cover all pumping stations to be rehabilitated. Meters read in m³ and are recorded twice daily, once in the morning and once in the evening. Recommended that they recorded a 6 digit number each time which includes the leading 0's to avoid confusion. Also recommend that they record total pump hours, which will assist both with maintenance and with alternate usage calculations.

New pump houses and meters for the rehabilitation and electrification of 23 production bores in Mataki'eua

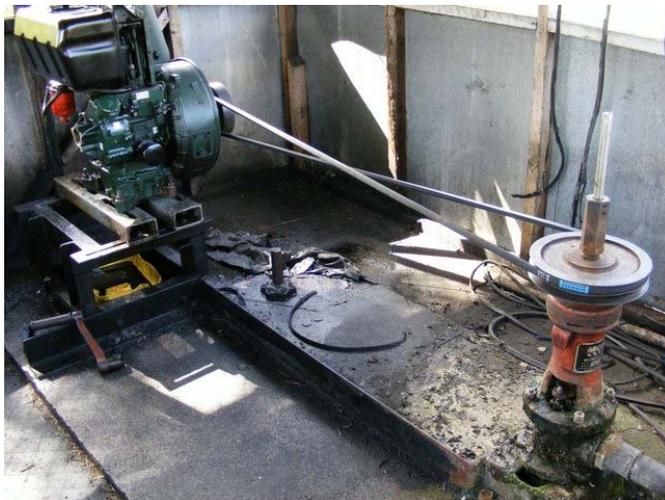
Village	Latitude	Longitude	Estd DTWT	Comments
Fatai	S21°08.158'	W175°16.678'	8-10m	Dug well with manhole. No sampling tap. No meter on pump or from header tank. Header tank leaking. Pump previously solar, currently diesel. No obvious threat of contamination (although some potential for hydrocarbon contamination from current diesel operation)
Fahefa	S21°08.832	W175°19.824'		Drilled bore 6" casing, no access to well, 2" sampling tap. Meter on outlet of tank from header stand operating (019834m ³) 12:20 23/6/10, Fibreglass header tank No obvious threats of contamination. Diesel pump currently, proposal for electrification
Kala'au	S21°08.275'	W175°20.248'		Dug well 2x3m. Very old Southern Cross handpump. Access via manhole Well located in middle of village with threat of contamination from septic tanks. Closets tank is approx 5m (Church hall, limited use) Three septic tanks attached to houses 25m, 30m, and 30m. Red soils 1m thick underlain by limestone. Well believed to be 12-15m deep. Diesel operated helical pump pumps approx 200m to new header tank with meter?

Typical village well set up +ve displacement helical pump and Lister diesel motor
