# TONGA

## ATATA ISLAND, KOLOVAO DISTRICT, TONGATAPU DIVISION

IMAGERY ANALYSIS: 18/JAN/2021 PUBLISHED 18/JAN/2021 V1.

### Damage assessment in Atata Island, Kolovao district, Tongatapu division, Tonga as of 18 January 2022

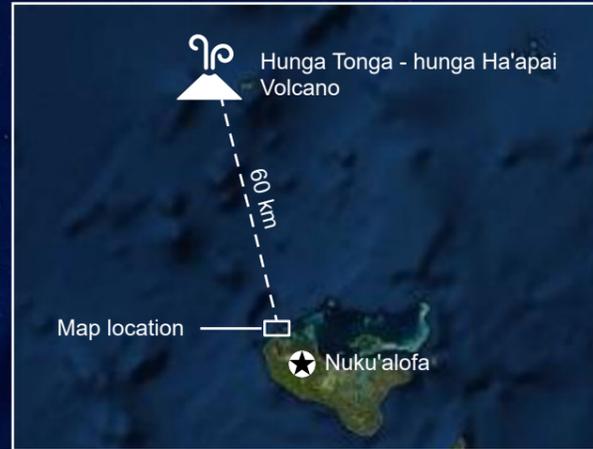
### ATATA ISLAND

AREA AFFECTED  
62 ha

DAMAGED STRUCTURES  
72

POTENTIALLY DAMAGED STRUCTURES  
28

This map illustrates impact of the Hunga Tonga-hunga Ha'apai volcanic eruption and subsequent tsunami in the Atata island (Kolovao district, Tonga) and the related damage assessment as detected from a Pleiades image acquired on 18 January 2022, 19:45 local time. Within this island, UNOSAT identified 72 structures as damaged, 28 structures as potentially damaged. Furthermore, the entire island appears to be covered with volcanic ash.

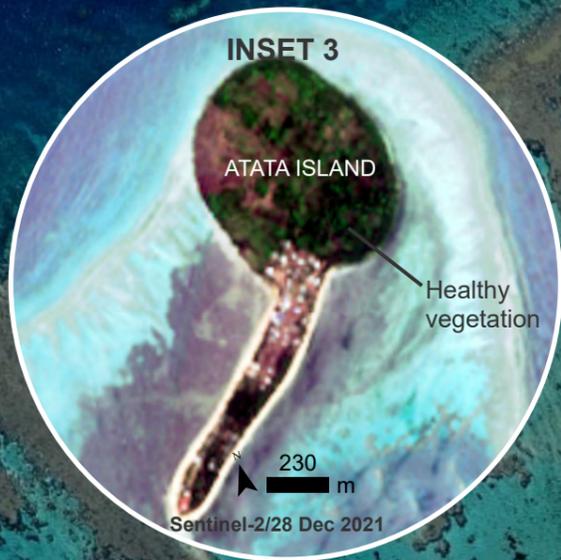
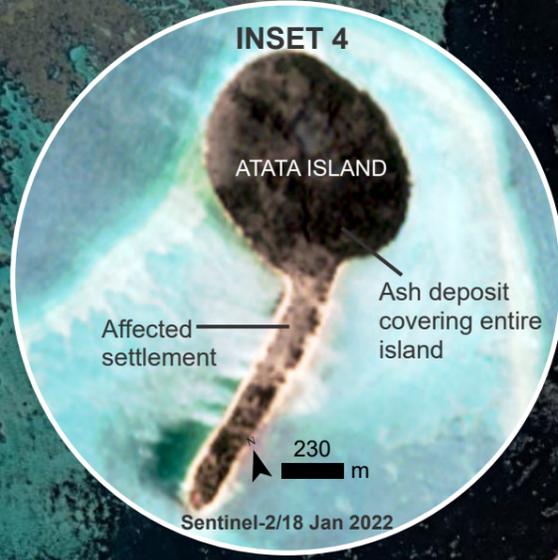
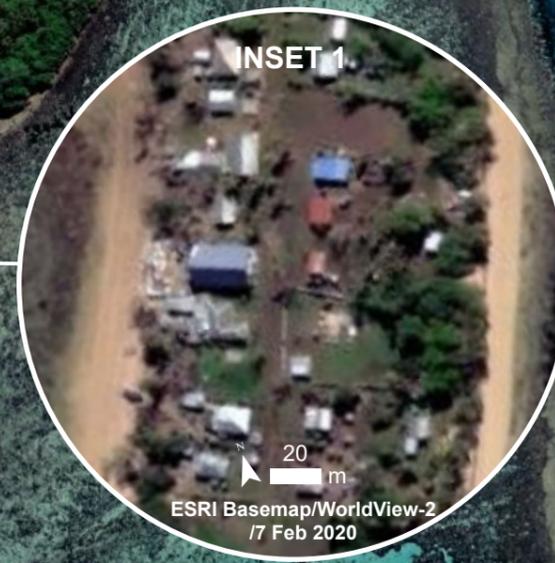
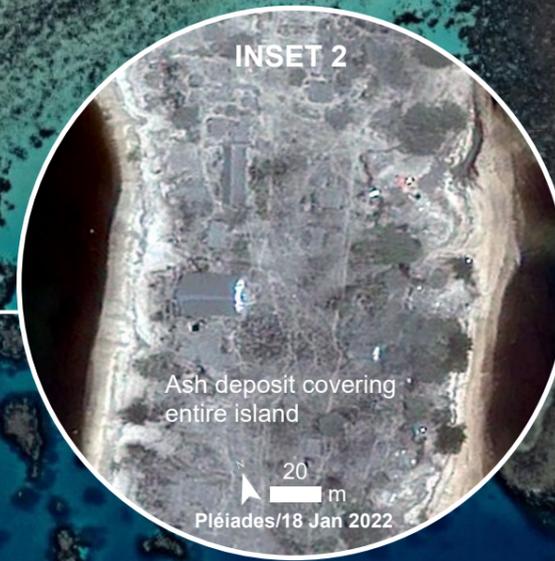
See inset 3 & 4 for overview between before and after the volcanic eruption
