FONOIFUA VILLAGE, MU'OMU'A DISTRICT, HA'APAI DIVISION

IMAGERY ANALYSIS: 20/01/2022 PUBLISHED 20/01/2022 V1

Damage assessment in Fonoifua Island, Mu'omu'a district, Ha'apai division, Tonga as of 20 January 2022

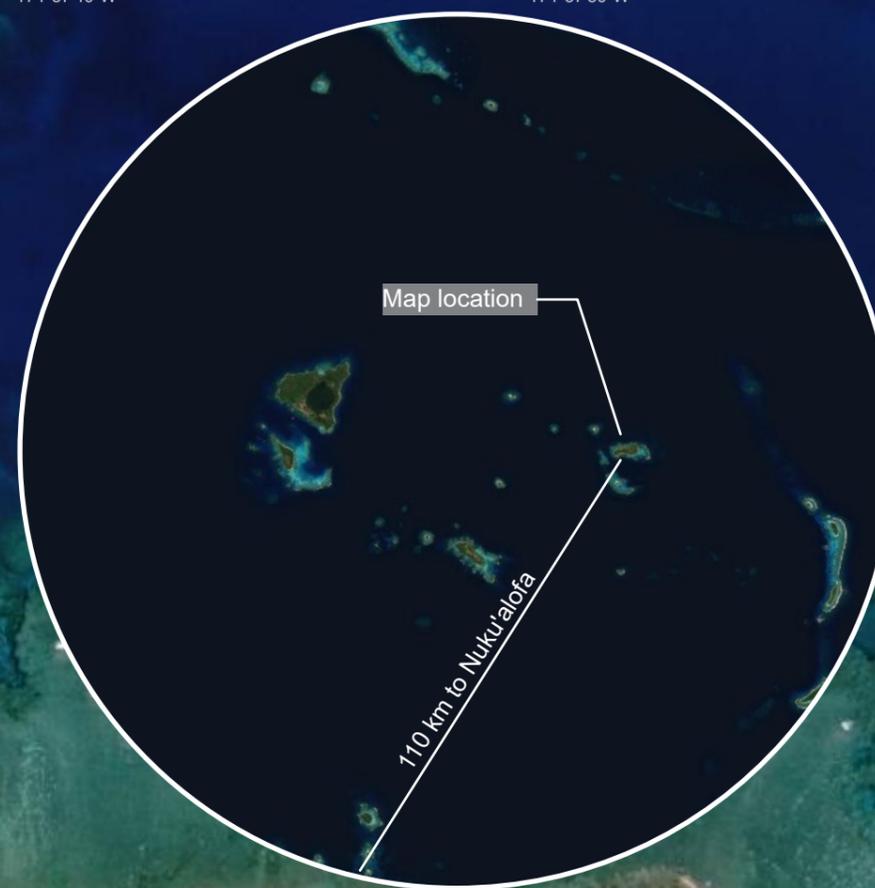
DAMAGED STRUCTURES
 30

POTENTIALLY DAMAGED STRUCTURE
 7

This map illustrates the impact of the Hunga Tonga-hunga Ha'apai volcanic eruption and the subsequent tsunami in Fonoifua island located at 110 km NE of Nuku'alofa and also the building damage assessment as detected from a Pleiades image acquired on 20 January 2022, 12:43 local time. In this island, UNOSAT identified 30 structures as damaged and/or destroyed and 7 structures as potentially damaged. The entire island appears to be covered with ashes. This is a preliminary analysis and has not yet been validated in the field. Please send ground feedback to UNITAR-UNOSAT.
