# Status of Fanga'uta Lagoon 2016

Ridge to Reef Project, Kingdom of Tonga

## **STATUS OF FANGA'UTA LAGOON 2016**

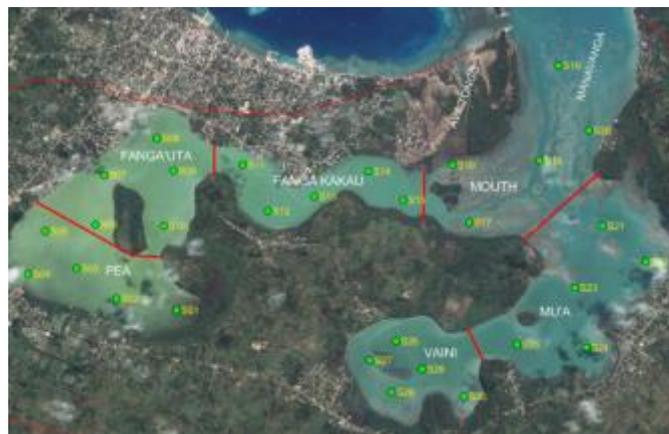
Figure 4: Location of marine survey sections and sites

comparisons with data collected up to 18 years ago. The areas of the lagoon surveyed were Pea, Fanga'uta and Fangakakau in the western arm, Vaini and Mu'a in the east, and the Mouth of the lagoon, with 5 sites within each Section and a total of 30 sites throughout the lagoon (Figure 4).

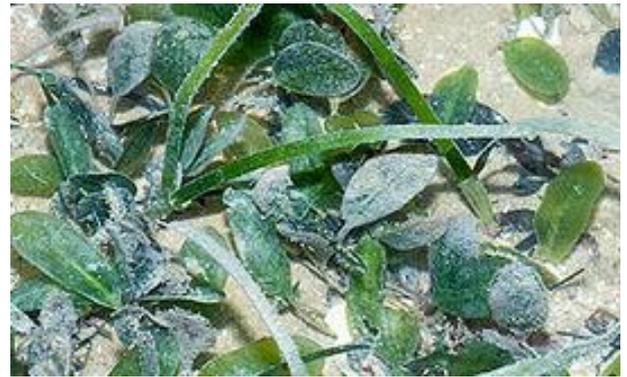
Figure 10: Seagrass species common in the lagoon

Strap-like seagrass is *Halodule uninervis*,  
Oval leaf is *Halophila ovalis*.

There have been large changes in the species of seagrasses found in each of the lagoon sections since 1998 (Figure 9). Dominance by *Halodule uninervis* fell at all sections since 1999. At some sections (Fanga'uta, Mua and Pea) there was also a drop in *Halophila ovalis* cover over time. Overall, at most of the sections of the lagoon there was a decline in seagrass cover involving both of these species (*Halodule* and *Halophila*) (Figure 10). A

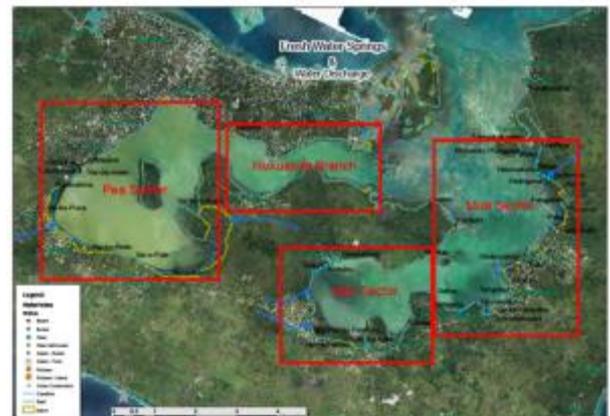
Figure 12: Fresh Water Springs surveyed at 4 Sectors of Fanga'uta Lagoon (Source GIS, MLSNR)

**Freshwater springs:** The Lagoon was divided into four main Sectors for the survey of springs (Figure 12), adopting the approach from a previous study (13) on the hydrodynamics of the Lagoon to simplify the display of surveyed data. The four Sectors were Pea Sector, Nuku'alofa Branch, Mu'a Sector and Vaini Sector. The Fresh Water Springs were originally identified from previous consultancies, in 2015, with Town Officers, District Officers and some members from each community.

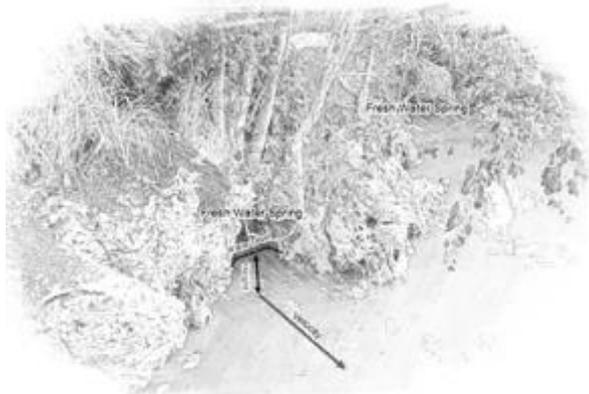
Figure 13: Diagram of how water discharge was measured

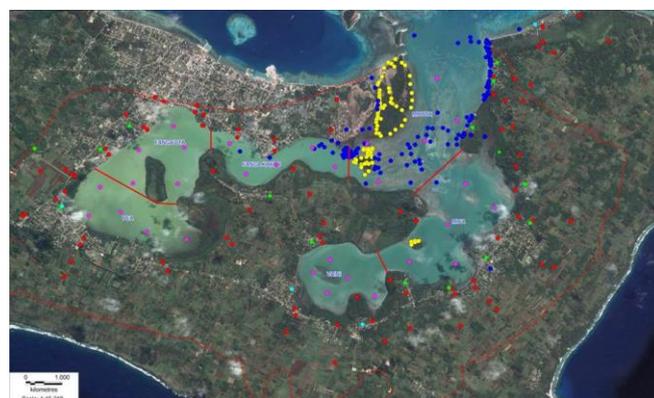
Figure 15: The location of soil samples in red dots

A total of 99 soil samples were taken as depicted by the red color dots in Figure 15 below.

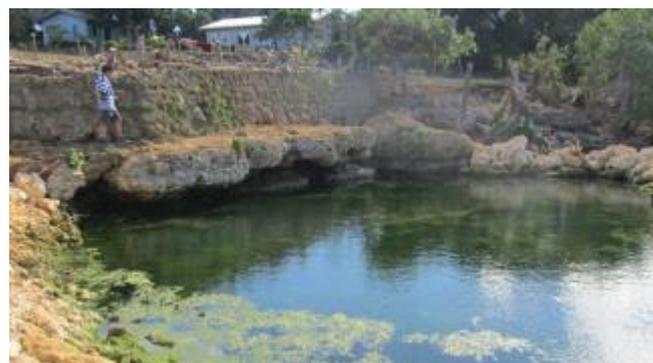
Figure 17: Vai a Fafine – Vai a Tangata at Vaini during 2015 survey

- The FWS was buried under silt
- Rock fall at the opening of the Spring: Photos 2 & 3
- It was fairly high tide at the time of survey

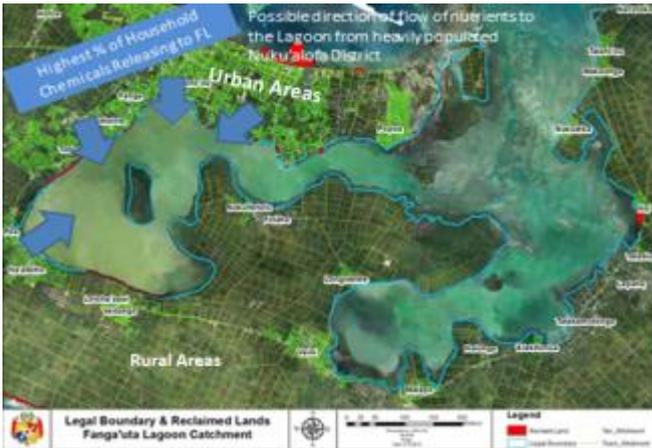
From previous studies of the status of the lagoon, it was found that majority of nutrients, heavy metals and sediments flowing into the lagoon from Urban Areas via storm water and road drainage were originally from households and developments around the lagoon as shown in Figure 19 below.

Figure 19: Shows possible Direction of flow of nutrients to the Lagoon from heavily populated Nuku'alofa Urban Areas (source: GIS,MLSNR 2016)

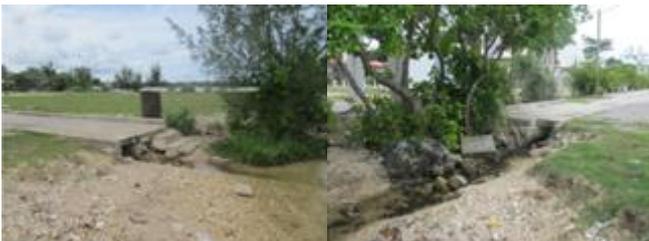
During field inspection of Urban areas, it was found that means of flow of pollution to the Lagoon were probably from three sources, basically; i. Surface Runoffs, ii. Overflows from permanent polluted Swamps and old Rock Quarries, and iii. from Road Drainage Outlets, as shown in photos below.

Figure 20: Drainage outlets at Fanga o Pilolevu (left) and Pahu (right)

6. Road drainage systems were identified as a significant pathway for lagoon pollution. It was recommended that water retention ponds be developed to filter out sediments and prevent them moving towards the lagoon.

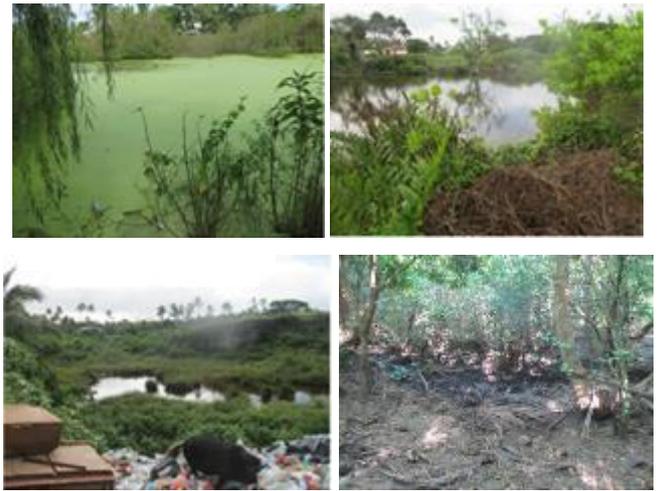
Figure 21: Other sources of pollution flow

Top left: Swamp at Ngeleia; Top right: 'Ananaa; Bottom left: Low area at Old Pili Quarry; Bottom right: Pig damage

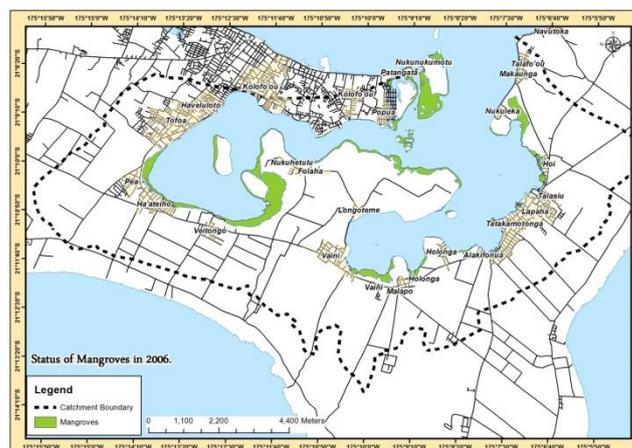
Figure 25: Mangrove distribution in Fanga’uta  
Data are from 2006 with total extent of 4176883.6 square meters. (GIS Unit, MLNRS)

In the provided map, it advised that Fanga’uta Lagoon has about 417.69 ha of mangroves on sites. Nukuhetulu area is comprised of one of the oldest mangroves in the Pacific comprising of about 330 ha, that is about 79% of mangroves coverage at the lagoon approximately.

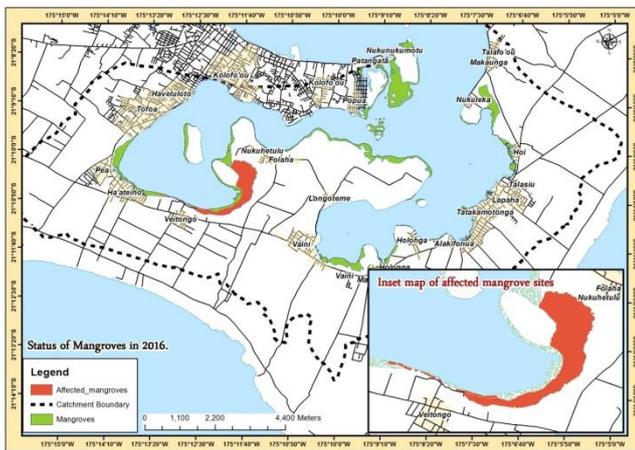
**Figure 26: Distribution of mangroves in 2016**

The total extent of in 2016 was 3300265.7 square meters whereas the area assumed to be affected is 876617.9 square meters ((GIS Unit, MLNRS)

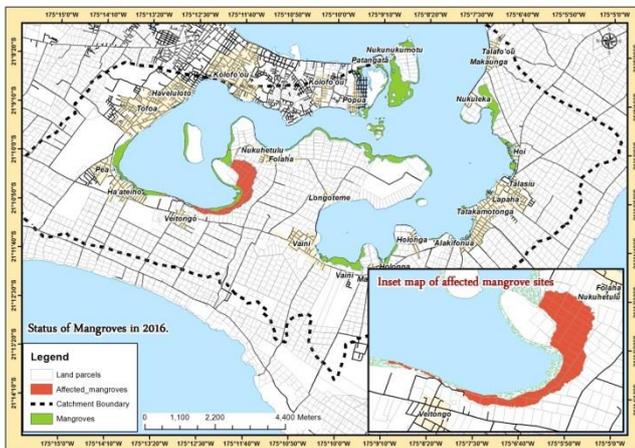
**Figure 27: Overlay of subdivisions on mangrove lands**

These were undertaken against the mangrove ecosystem around Fanga'uta Lagoon Catchment area. GIS Unit, MLNRS)

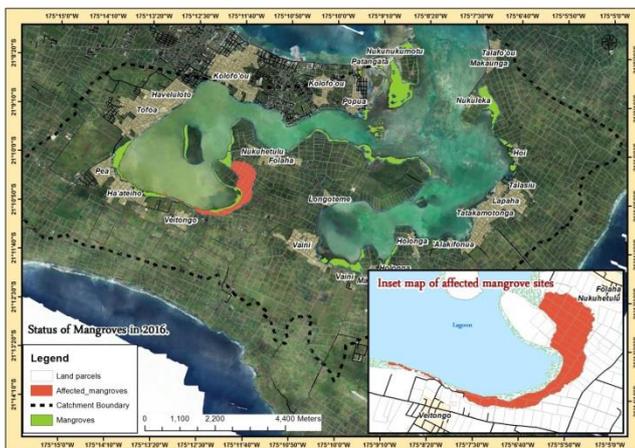
**Figure 28: Satellite imagery as backdrop to ground-truthing**

This shows the spatial distribution of mangrove ecosystem over Fanga'uta lagoon catchment in 2016. (GIS Unit, MLNRS)

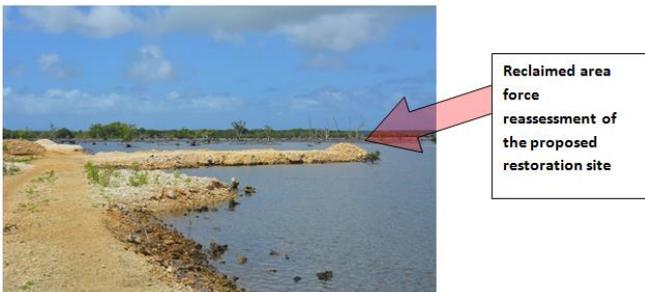
Figure 31: Reclaimed lands blocked tidal flow

This lead to high mortality of natural regeneration and increase water level in one of the proposed replanting site at Popua. (Photo by Iliesa Tora)

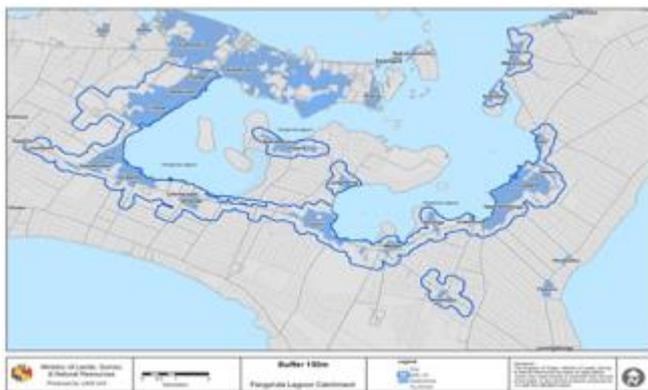
Figure 35: Zone 1 - 150m Buffer – limiting the use of dangerous agricultural chemicals

- It has been recommended by key personnel from relevant stakeholders to categorise crops farming within the catchment into high to low usage of agricultural chemicals then apply them into the Land Use Zoning in the Plan:
- Zone 1: Crops with need for or very minimal usage of agricultural chemicals – Kava, pineapples, hopa,

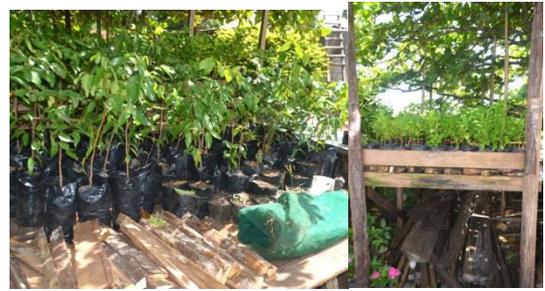
Figure 29: Home-based mangroves nursery to address limited fresh water supply and high salinity

- Accessibility of fresh water supply to nursery is vital to future mangrove nursery in low lying areas of Tonga. The method of building home-based nursery is a good technique to adopt in areas with poor supply of water and salinity from underground water lens fit the physiological needs of local species (Figure 29)

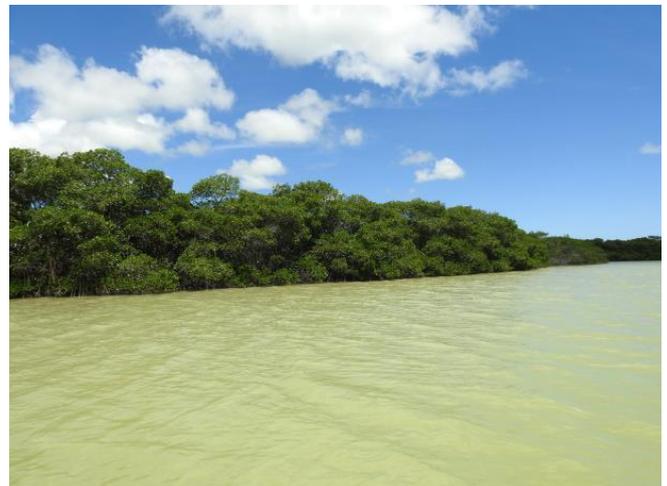
*Figure 41: Pea Section showing discoloured water implying possible stressors for bird habitats*

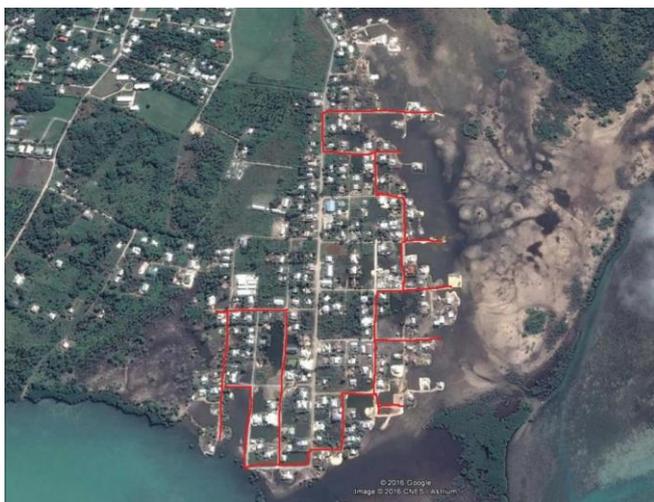
Figure 42: Popua area on the northern side of the lagoon with roads used in the survey shown in red

The Popua settlement east of Tongatapu borders an extensive area of mudflats and sandflats that are partly covered at high tide and shallow ponds between houses. This area was visited on three days driving to each of the road ends overlooking the lagoon (Figure 42), the third occasion including repeat visits to document bird activity at different stages of the tide.

1. Based on driving the tracks shown in red in Figure 42; and
2. Observations made from the ends of the six tracks projecting into the lagoon to the east of the settlement.

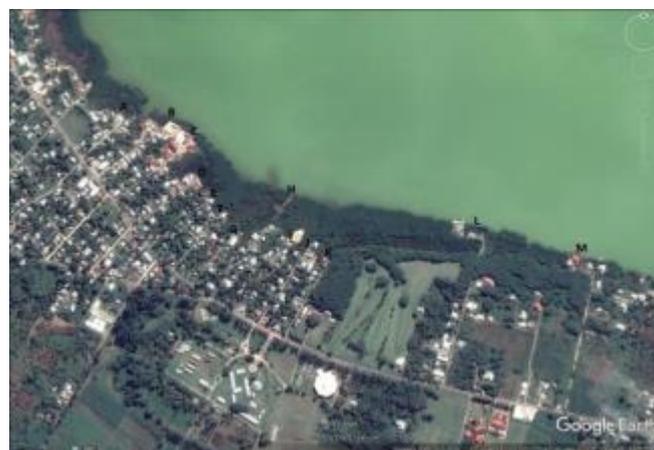
Figure 43: Road end locations surveyed from Ha'ateiho village

The survey based on the road around the lagoon revealed small numbers of birds at various locations but no areas held as many as Popua. Figure 43 shows an example of the survey conducted from Ha'ateiho village. Table 2 shows the results of surveying the road ends in Figure 43.

*Table 6: Road-end observations in Ha'ateiho area at sites shown in Figure 43*

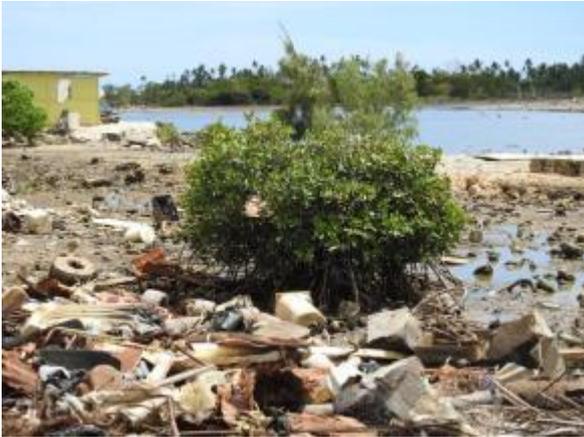
*Figure 44: Rubbish at the edge of the lagoon, Popua*

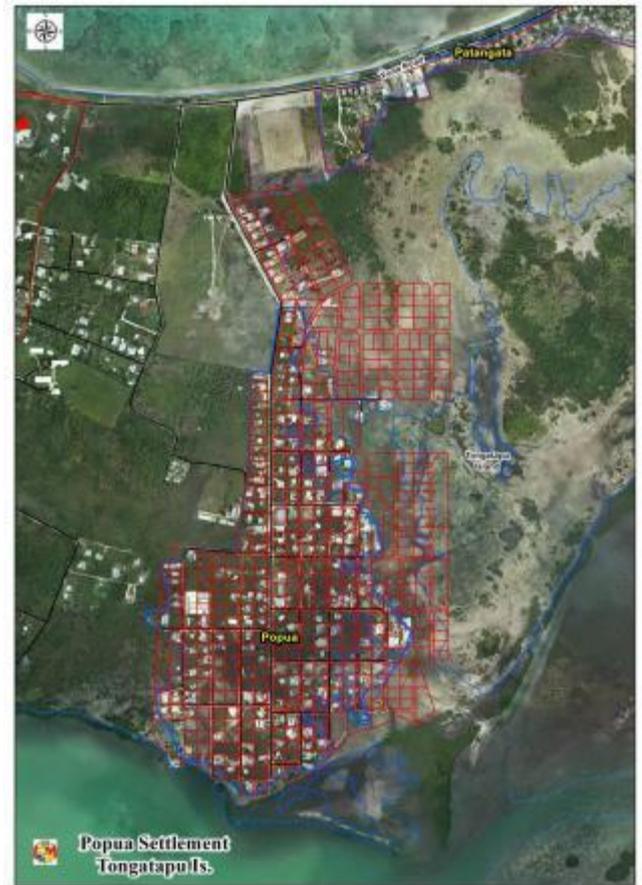
*Figure 46: Popua settlement showing (in red) all planned sections for development*

However the main threat is the loss of bird habitat due to the settlement itself. Figure 46 shows that a further significant area is due to be occupied by housing including the main areas subject to tidal flow that were used by wading birds during the survey. It is understood that many of the allotments have been leased and registered allocated so that it may be too late to prevent this happening.

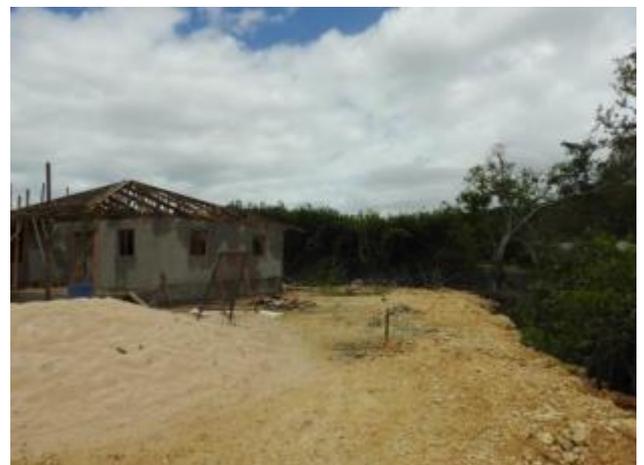
*Figure 47: Mangroves cleared for house under construction*

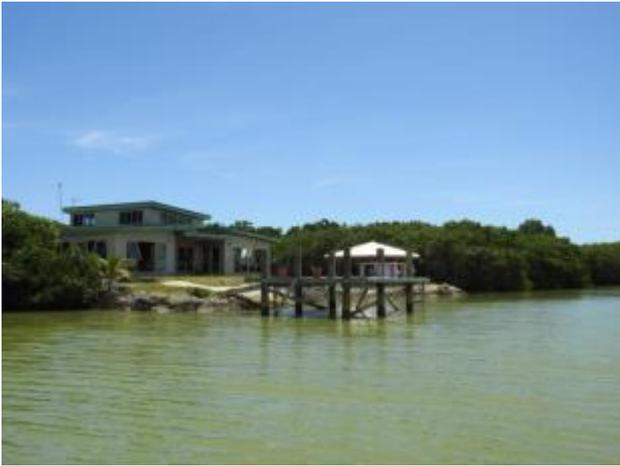
Figure 48: Reclamation within mangrove area

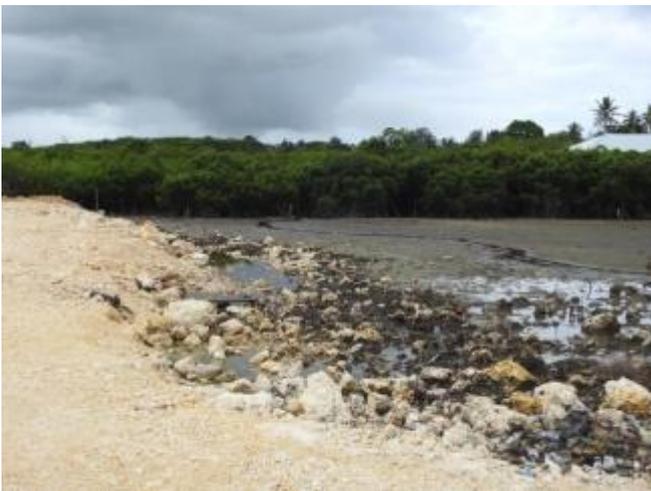
Figure 49: Road construction through mudflats

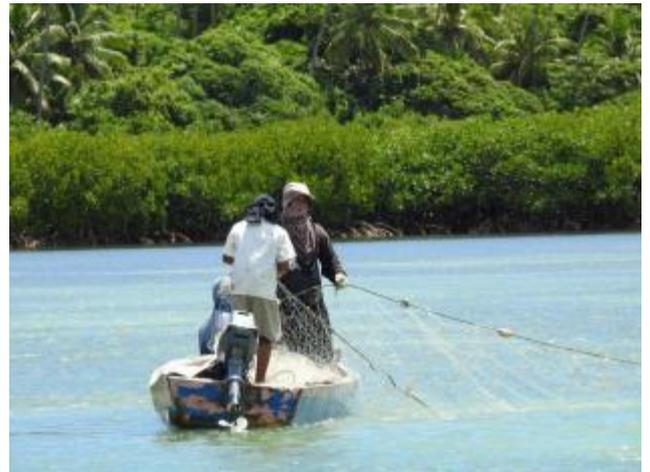
Figure 50: Hauling in a gill net

In addition, over-fishing of the lagoon will have reduced the food for some species and may explain why no seabirds other than coastal terns appeared to fish there. We observed significant fishing effort with many gill nets set within the lagoon (Figure 50). In particular, long sequences of nets were set close to the edge of the mangroves (Figure 51). Apparent overfishing has been documented in the recent R2R survey, with fewer finfish caught than in equivalent surveys elsewhere in Tonga and significant numbers of households reporting declines in catches and fish size compared to 5 years ago (18). This has been a continuing trend as household surveys conducted in 2001 revealed that quantity and quality of fish and shellfish catches in the lagoon had declined over the years and were continuing to decline rapidly (6).
