TONGA WATER BOARD INSTITUTIONAL DEVELOPMENT PROJECT

WATER MONITORING BOREHOLE INSTALLATION

MATAKI'EUA and SURROUNDS, TONGATAPU

JUNE 1997

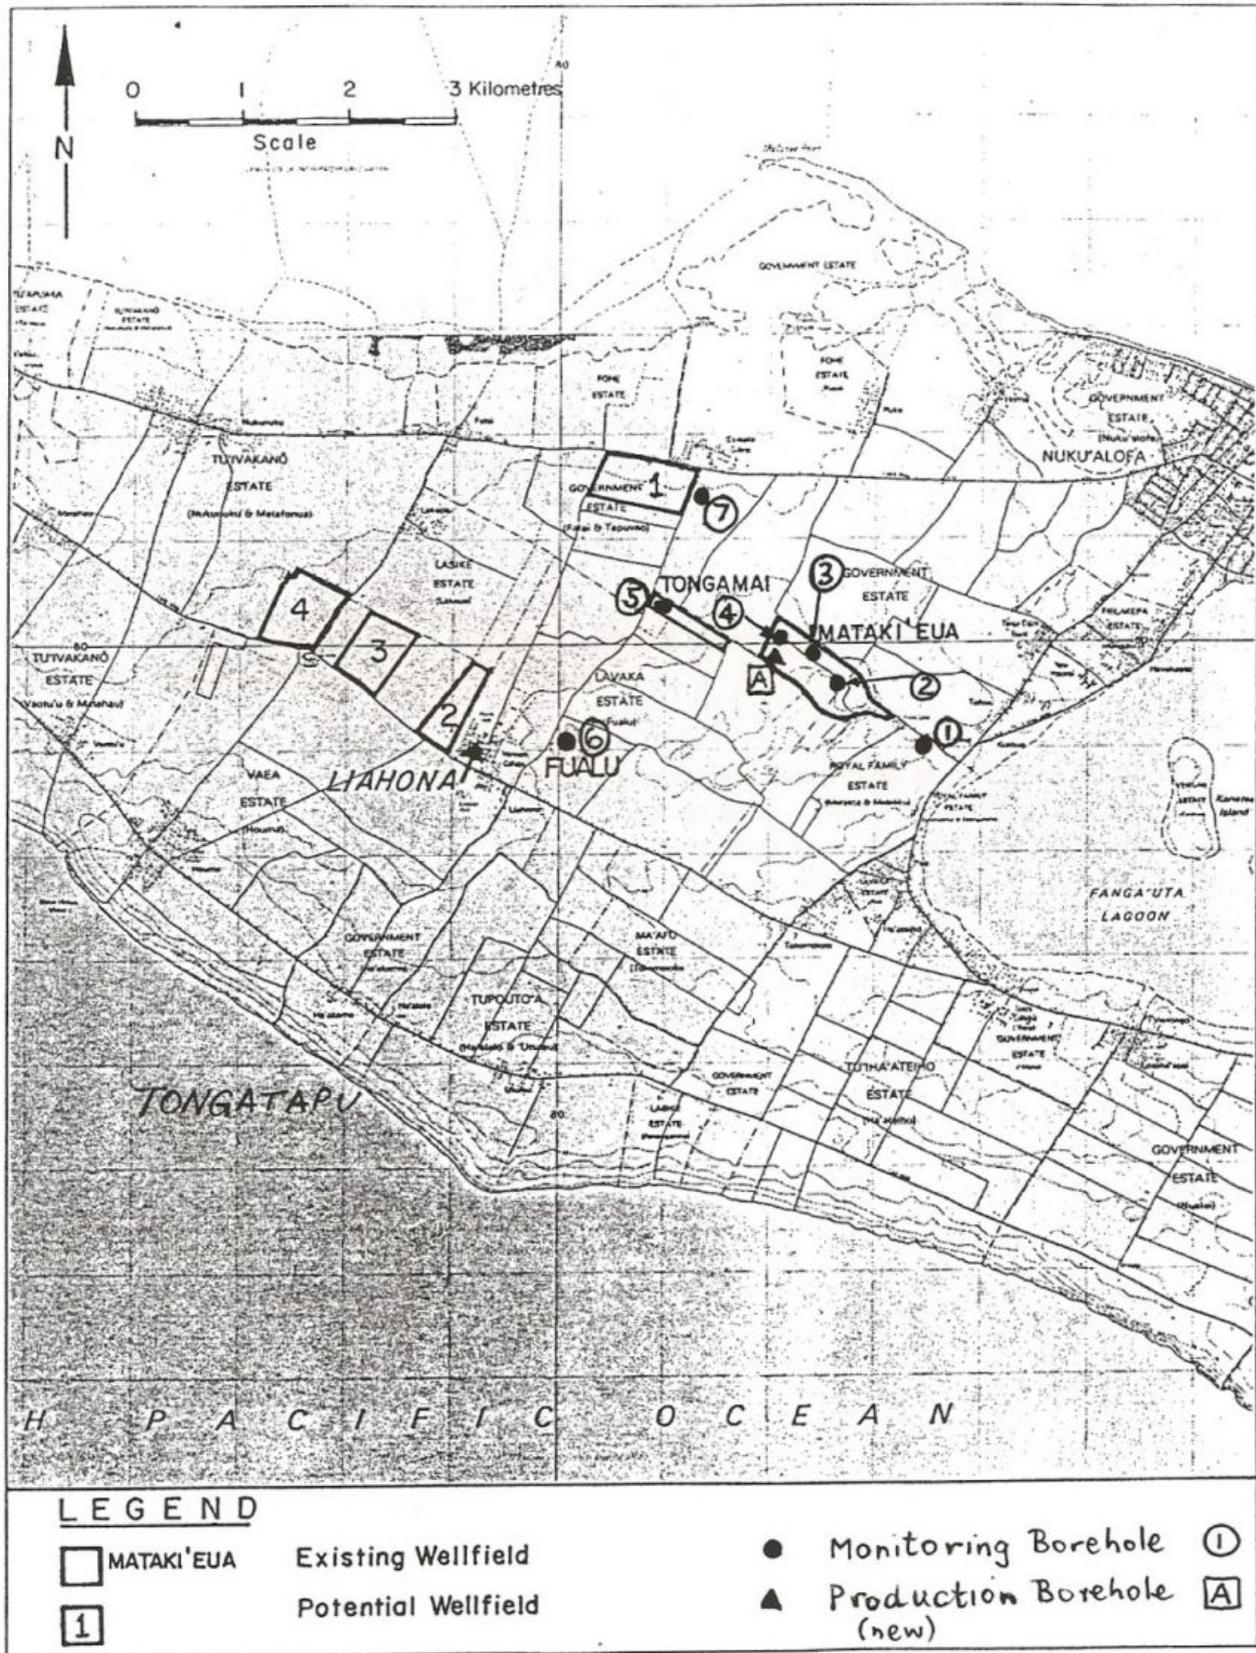
Location of boreholes (at and near Mataki'eua)

This drawing is based on Drawing 1 of Furness L. (1996). Report on Visit to Tonga, 8-16 May 1996, prepared for ACTEW Corporation, Douglas Partners, June 1996.

Locations of all holes are shown in Figure 1 and listed in Annex C.
