THE HYDROGEOLOGY AND WATER SUPPLY

THE KINGDOM OF TONGA

Lindsay J. Furness  
Hydrogeologist

Saimone P. Helu  
Government Geologist

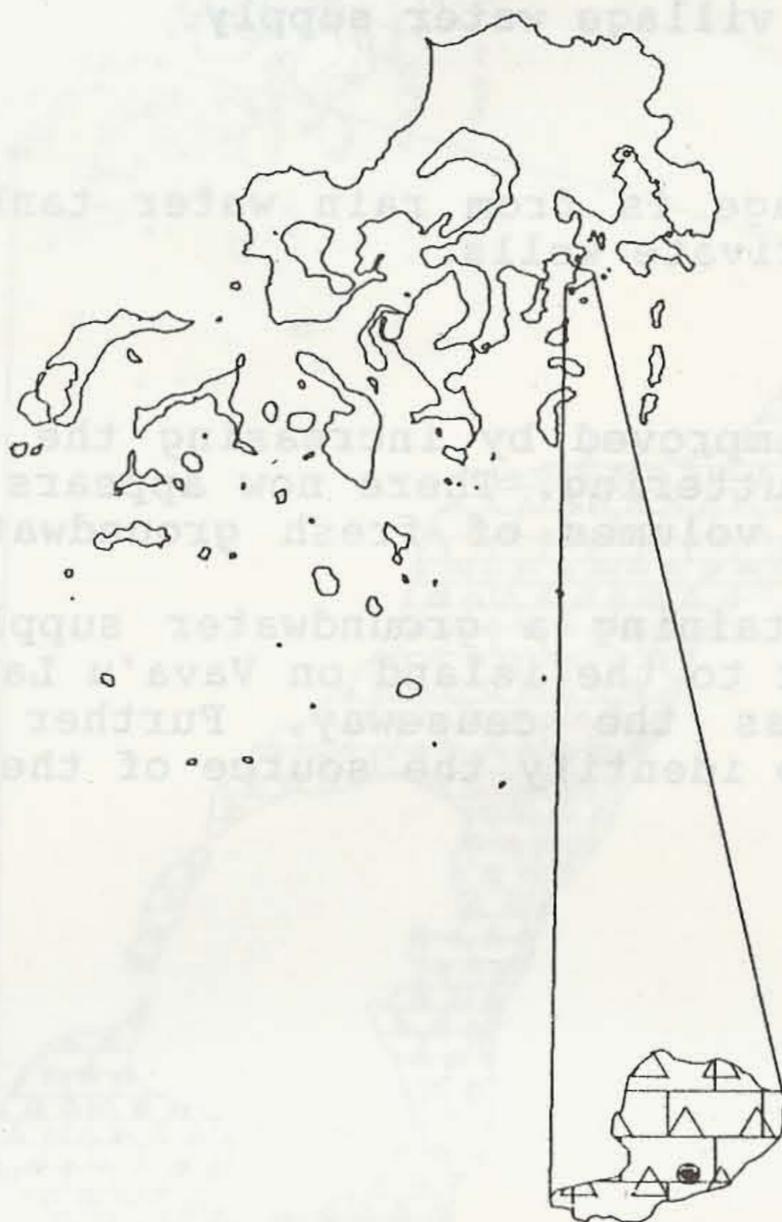
Fig. 6.4.8

A hydrogeological inspection and test drilling were carried out on 'Okoa in 1991. The island is almost circular and relatively flat, being only 20 metres above sea level. It is connected to Vava'u Lahi by a causeway.

The next step in obtaining a groundwater supply for 'Okoa is to drill adjacent to the island on Vava'u Lahi and to pipe the water across the causeway. Further EM-34 studies need to be made to identify the source of the fresh water.
